NAEC-91-7964

INVESTIGATION OF CROSSDECK PENDANT CATAPULT SLOT INTERACTION; PROPOSED CORRECTIVE MEASURES FOR

20 NOVEMBER 1981

Final Report for Period April 1978 through March 1979
AIRTASK A5515512/0514/0551000117

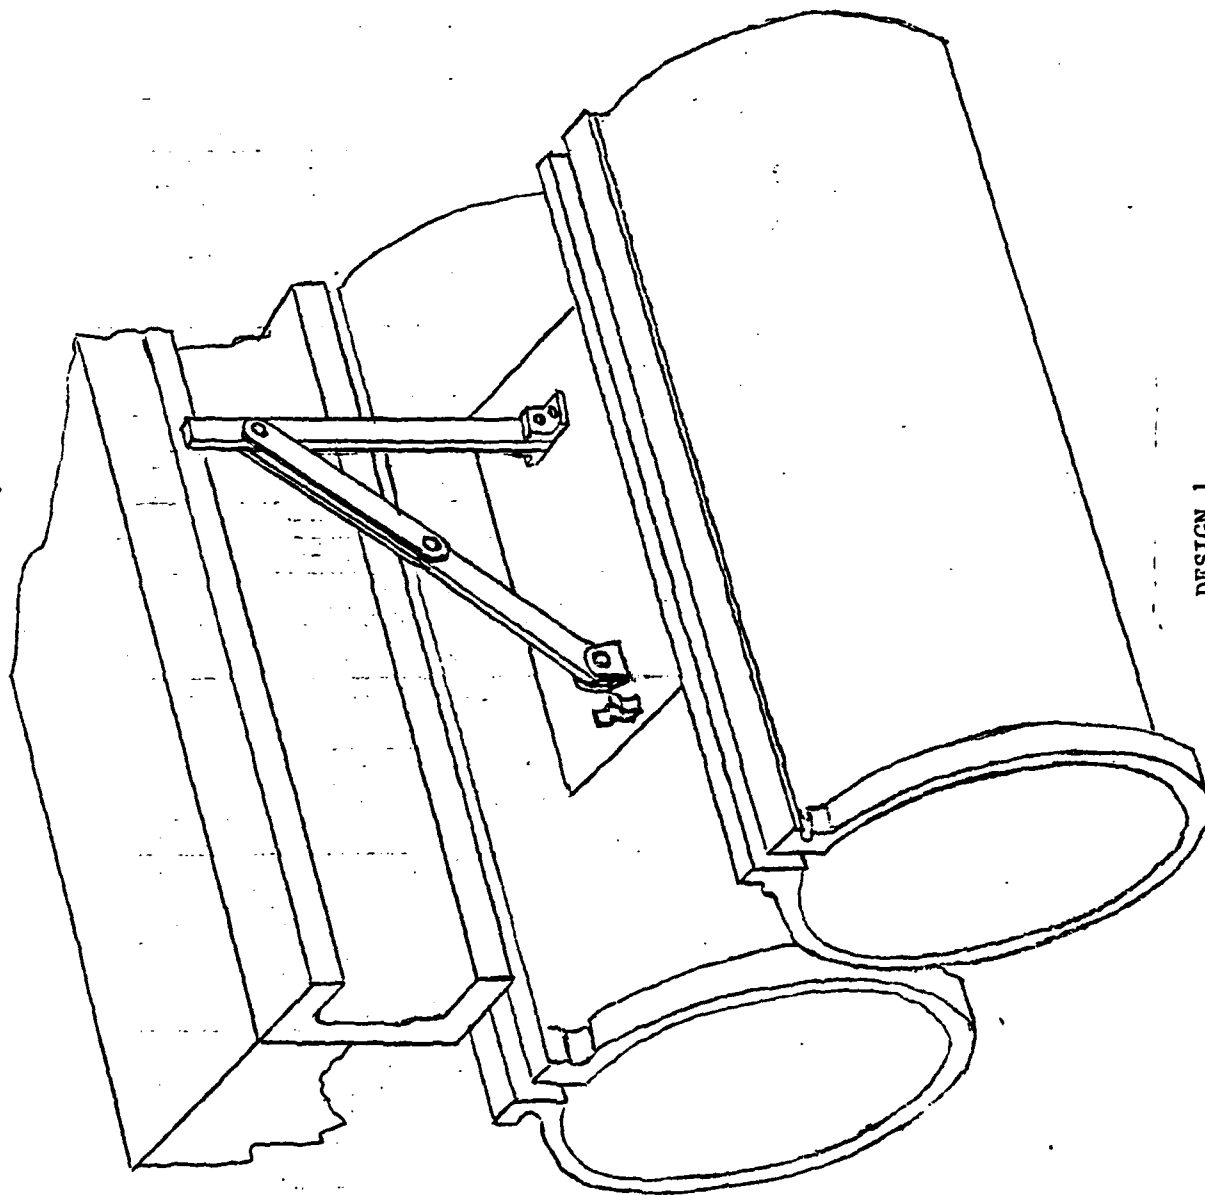
DESIGN 1
FIGURE A-1

Design 1 - Single Stanchion: Stanchion folds between cylinders below grab cables. Manually raised with tool inserted through track slot. Lowering occurs when support knuckle is broken and stanchion lowered with tool. Spacing - 6-foot centers. Self storing.
